Home Inspection Report

1234 Main St, Spokane , WA 99205

Sunday March 19, 2017

1805016

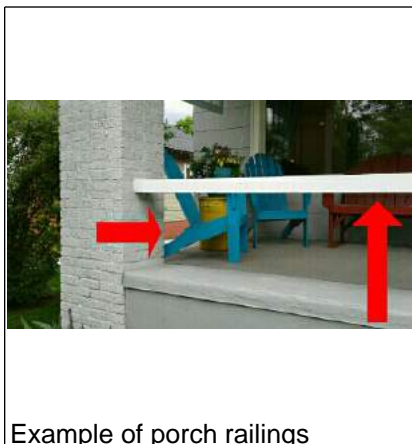
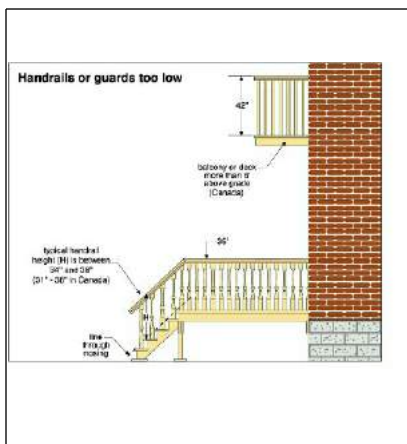
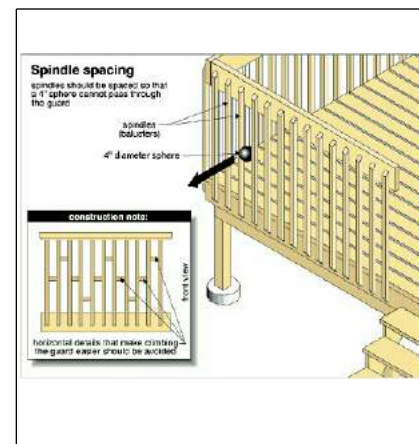
- Condition** Satisfactory Railing/Balusters recommended
- Support Pier** Concrete
- Floor** Satisfactory
- Comments** The porch did not have modern height guardrails to protect from falling off the porch, this was common for a house this age but is a potential safety hazard, I recommend a licensed contractor install the proper guardrails.
The porch guardrail balusters were not present, this is a typical modern safety standard for small humans, this is a safety hazard, I recommend repair by a licensed contractor.

Example of porch railings

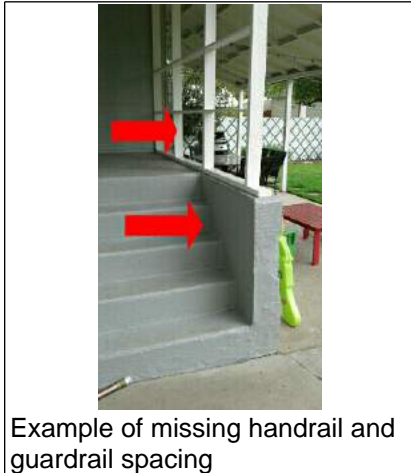
- Material** Concrete Railing/Balusters recommended
- Condition** Satisfactory
- Comments** The front and back steps did not have handrails to protect from falling off steps, this was common for a house this age but is a potential safety hazard, I recommend a licensed contractor install the proper handrails.
The back step guardrail balusters were spaced farther apart than typical safety standards for small humans, this is a safety hazard, I recommend repair by a licensed contractor.

Example of missing handrail and guardrail spacing

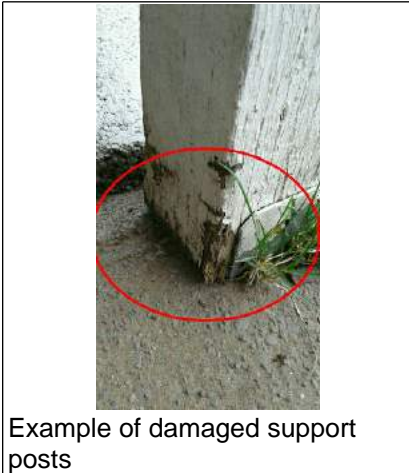
Comments The patio cover support posts had some damaged wood at the bases due to moisture, I recommend repair by a licensed contractor.

Example of damaged support posts

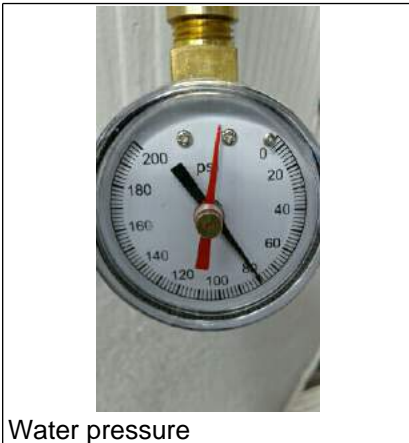
Water pressure

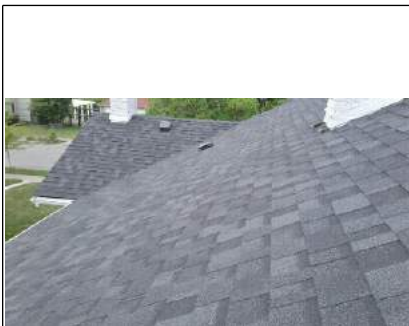
Example of main roof covering

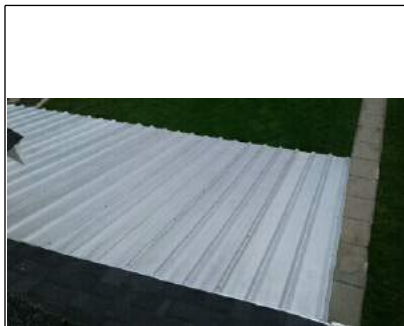
Example of patio roof covering

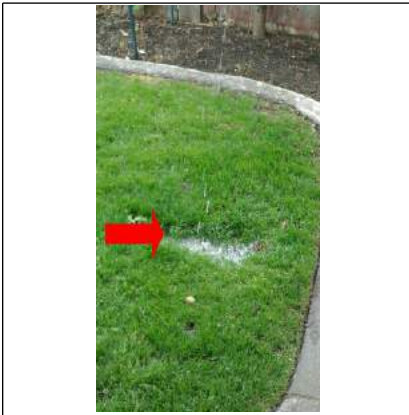
Comments The gutter downspout(s) were not present at some areas of the home, I recommend a licensed contractor add downspout(s) where needed.
The gutters were only on a portion of the house, I recommend additional gutters where needed.

Example of needed downspout

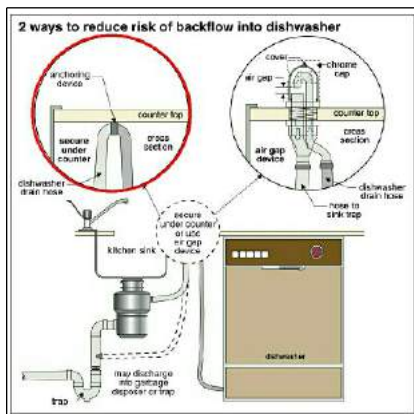
Comments The appliances were only tested for operation, working or not. The quality or extent of operation was not part of the testing or inspection.
The dishwasher drain line was not looped beneath the countertop, I recommend repair.
There was no anti-tip bracket installed on the range, this is a safety hazard, I recommend installing anti-tip bracket.
GFCI outlet(s) were installed on the ungrounded circuit(s) to help protect the occupants but were not labeled ungrounded, I recommend placing a sticker on each outlet labeling it as not grounded.

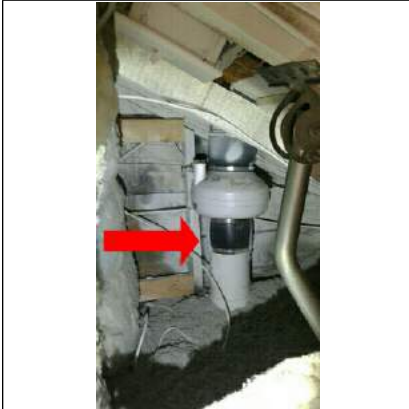
Comments Insulation and framing in attic, limited the view and ability to traverse attic.
There was a radon mitigation system present in the attic space.

Example of radon mitigation system

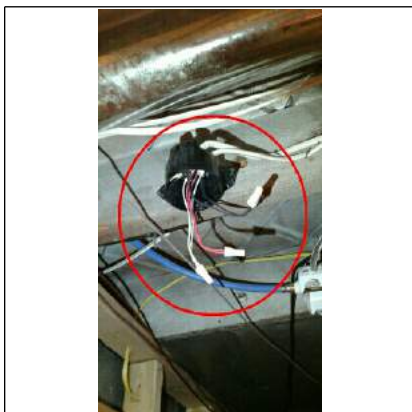
Comments Ther was an open junction box in the furnace room, this is a safety hazard, I recommend repair by a licensed electrician.
There were cover plates not present at receptacle box in furnace room, this is a safety hazard, I recommend repair.

Example of open junction boxes

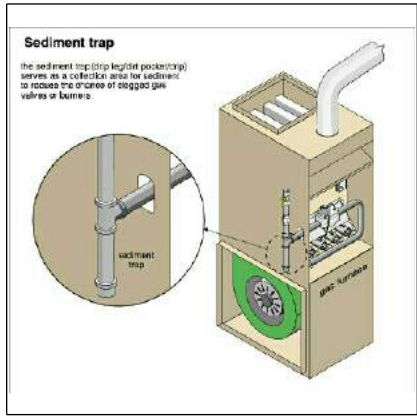
Comments Filter should be changed monthly.
 The heat exchanger was not visible and not evaluated.
 The gas piping did not have a sediment trap, I recommend a HVAC technician repair.

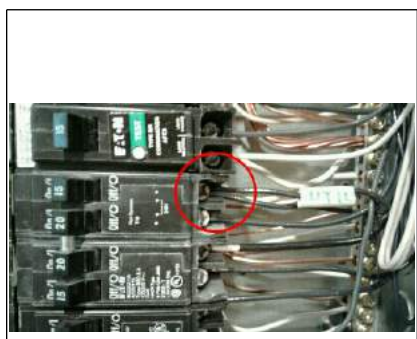
Location Basement
Condition Satisfactory
Adequate Clearance to Panel Yes
Amperage/Voltage 200a 120v/240v
Breakers/Fuses Breakers
Appears grounded Yes
GFCI breaker No
AFCI breaker Yes Operable: Yes No Not Tested
Main wire Aluminum Condition: Satisfactory Marginal Poor
Branch wire Copper
Branch wire condition Poor Recommend electrician evaluate/repair Double tapping
Comments Branch wires were double tapped, I recommend a licensed electrician repair.

Example of double tapping
