## Home Inspection Report

Main Ave, Spokane , WA 99203

Tuesday December 20, 2016

Home Pride Inspections LLC  
2525 E 29th Ave  
Ste 10B #312  
Spokane, WA 99203  
(509)855-9104  
info@homeprideinspect.com

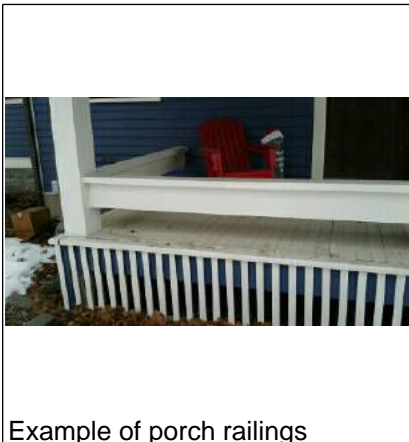
**Comments** Underside of porch not fully visible, no representation is made.  
Porch railing lower than typical safety standards for small humans, recommend repair  
Recommend painting or treating the wood on deck/porch

Example of porch railings

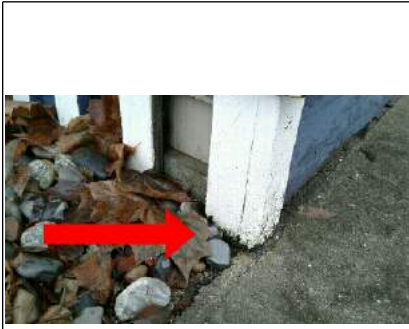
**Comments** Damaged wood on front and back steps, recommend repair and/replacement  
Earth to wood contact at some areas of steps, wood rot present, recommend repair.  
Baluster spacing larger than typical safety standards for small humans, recommend repair.

Example of Earth to wood contact

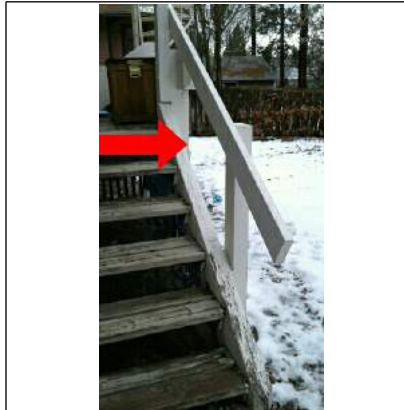
Example of balusters

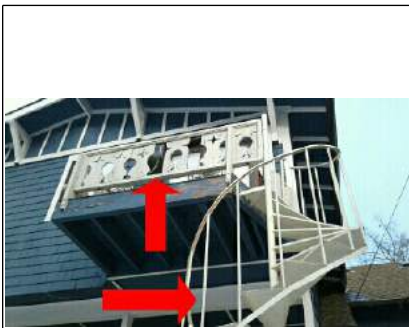
**Comments** Damaged, rotting wood on deck recommend repair and/or replacement.  
 For added safety recommend balusters on deck and speak staircase be spaced a maximum of 4" apart - safety concern for small children.  
 Balusters on balcony broken at some areas, recommend repair.  
 Recommend painting or treating wood.  
 Underside of deck not fully visible, not evaluated

Example of balusters

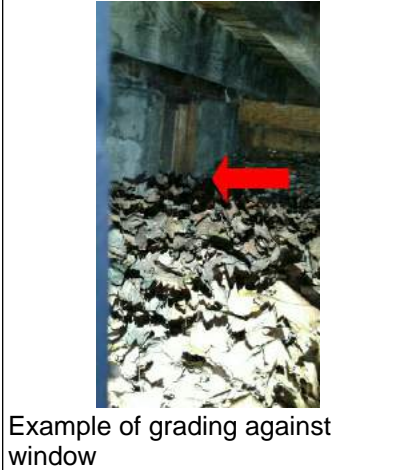
**Comments** Grading up against basement window under porch, recommend installing window well.  
Recommend additional backfill at some areas of house to create a proper pitch away from the house.

Example of grading against window

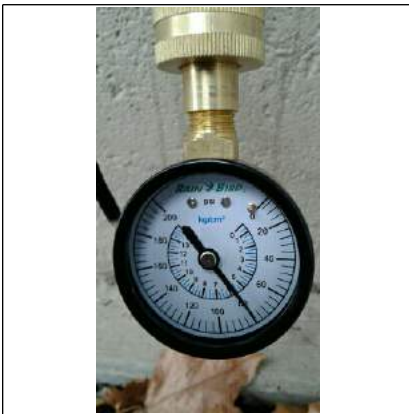
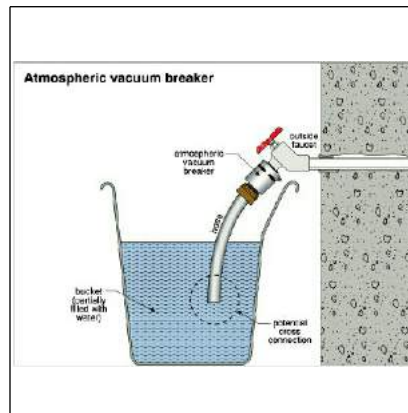
**Comments** Hose bib(s) not equipped with anti-siphon devices, possible cross connection can occur without anti-siphon device, recommend installing  
Recommend in winter to shut off valve on the inside of the house and open the outside faucet to allow drainage and to prevent freezing.

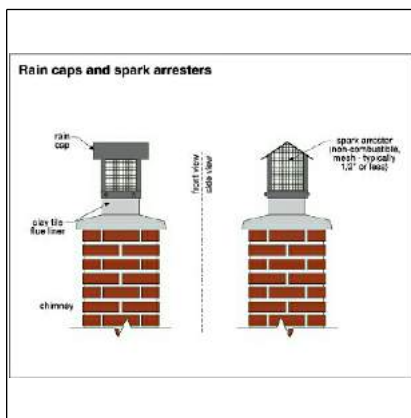
- Location(s)** Middle of Roof
- Viewed From**  Ground (Inspection Limited)  With Binoculars
- Rain Cap/Spark Arrestor**  No  Recommended
- Chase**  Brick
- Evidence of**  No apparent defects
- Flue**  Not Visible
- Condition**  Satisfactory
- Comments** Recommend installing rain cap/spark arrestor

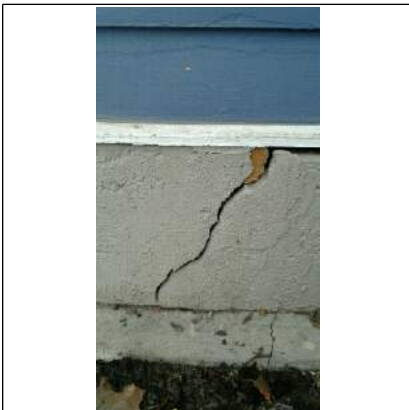
**Comments** North Foundation (stem) wall has vertical crack. Interior foundation wall not visible. Interior plaster crack above foundation crack, recommend monitor.

Example of foundation crack

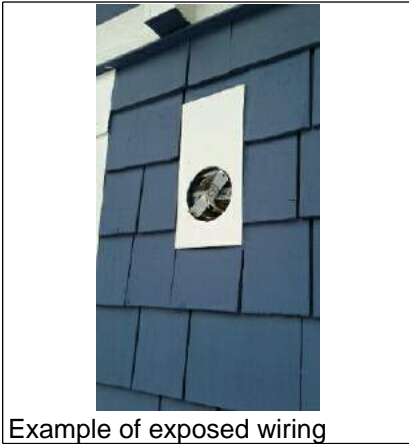
**Comments** Exposed, unprotected wire at South exterior, safety hazard, recommend repair.

Example of exposed wiring

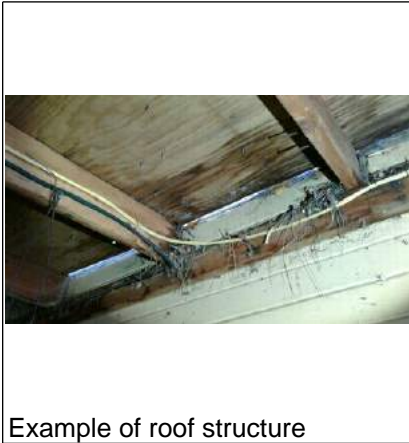
**Comments**      Roof was not visible, covered with snow  
Installation of South roof structure not typical. Gaps observed at some areas where roof structure meets exterior walls. Moisture stains/wood rot at some roof sheathing areas. Recommend repair.

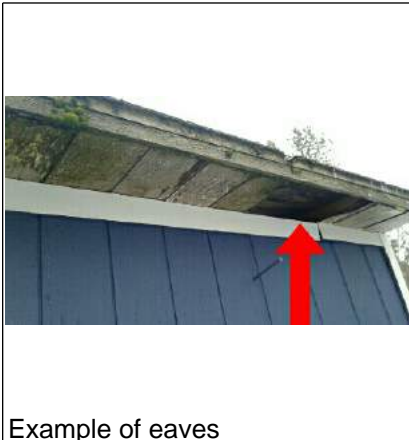
**Comments**      Eave at South garage leaking, wood rot present, recommend repair.

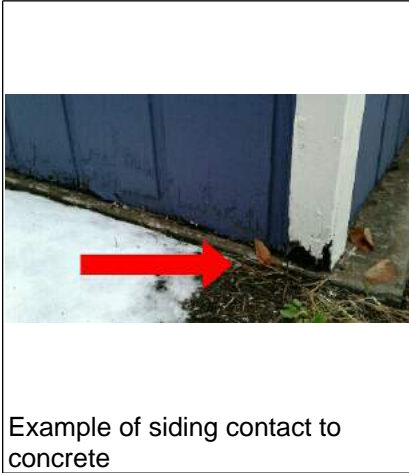
**Comments** Siding in direct contact with concrete, wood rot present, recommend repair.  
Moisture stains present at some areas of interior siding, recommend repair.  
Trim was in need of normal maintenance repairs.

Example of siding contact to concrete

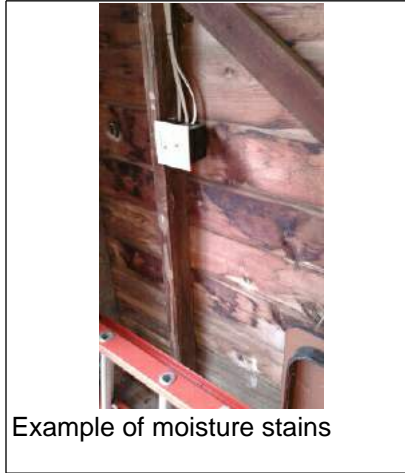
Example of moisture stains

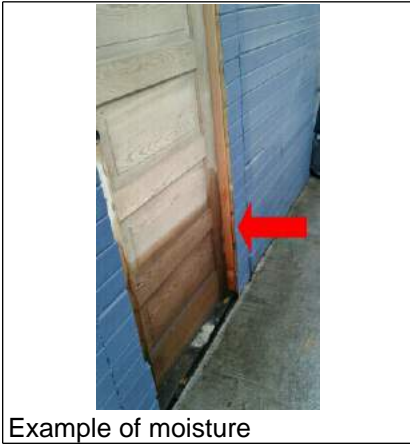
**Comments** Exposed wood at door and framing, moisture wicking up the door, recommend repair.

Example of moisture

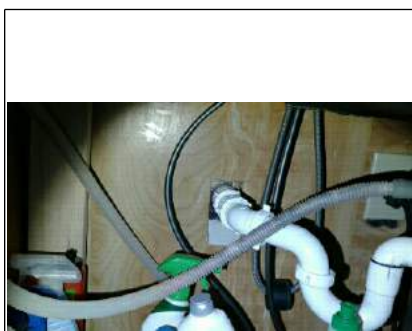
Comments Dishwasher drain line looped at sink base, recommend repair.

Example of dishwasher drain loop

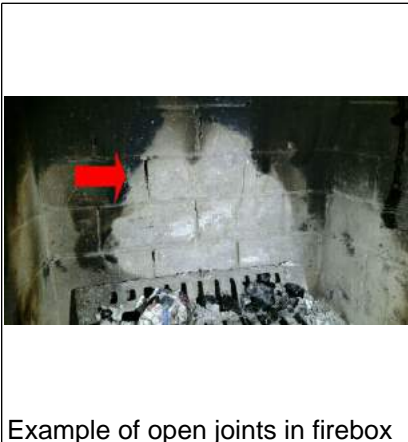
- Location(s)** Living room
- Type**  Wood
- Material**  Masonry
- Miscellaneous**  Open joints or cracks in firebrick/panels should be sealed
- Damper modified for gas operation**  N/A
- Hearth extension adequate**  Yes
- Mantel**  Secure
- Physical condition**  **Poor**  Recommend having flue cleaned and re-examined
- Comments** Damper is installed on chimney.  
Open joints or cracks in firebrick recommend properly sealing prior to use  
Creosote build up in flue, recommend cleaning

Example of open joints in firebox

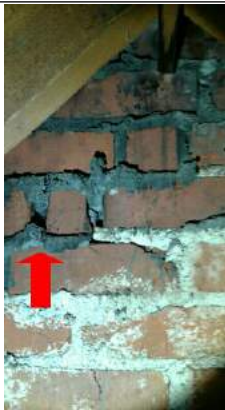
Chimney section through attic showed loose mortar joints, recommend repair

Example of loose mortar joints

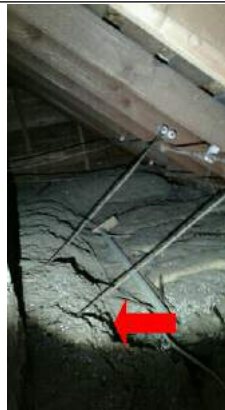
Knob and tube wiring covered with insulation not recommended. Recommend electrician evaluate.

Example of knob and tube in insulation

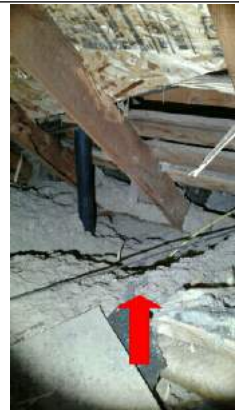
Insulation displaced at some areas of attic, recommend repair.

Example of displaced insulation

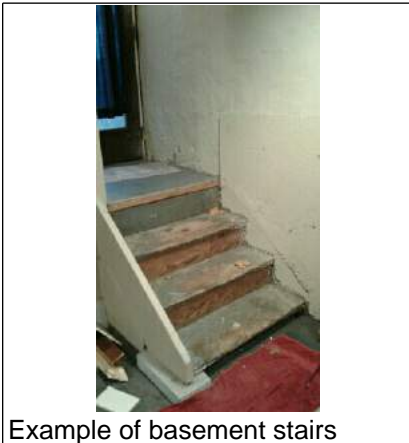
**Comments** Treads worn on stairs, possible safety hazard. Recommend repair/replace  
Handrail missing, potential safety issue. Recommend Installing handrail

Example of basement stairs

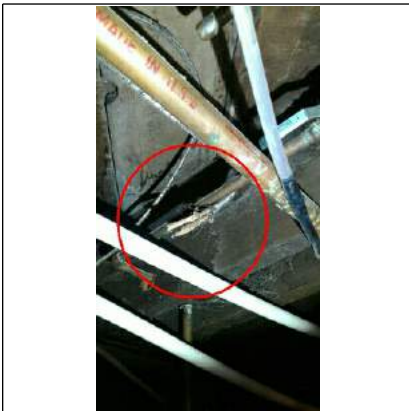
**Comments** Exposed, unprotected wire, safety hazard, recommend repair.

Example of exposed wires

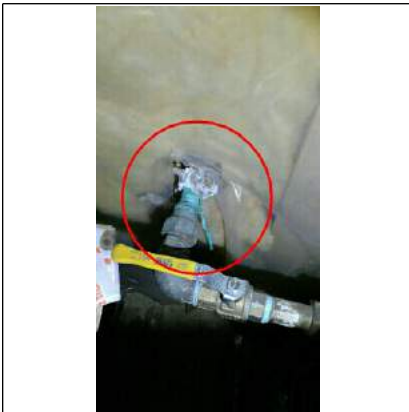
**Comments** Lead pipe present at the service entry  
Corrosion present at main water shut off, recommend repair.  
Limited view of plumbing in partially finished basement.

Example of corrosion

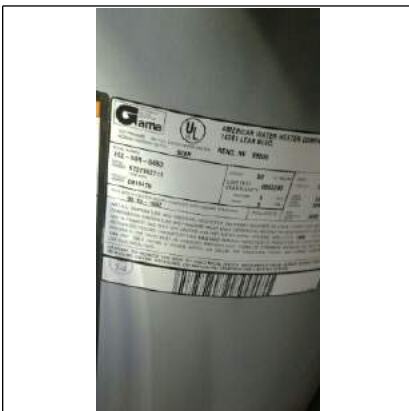
Comments Seismic restraints not installed, potential safety hazard, recommend installing restraints  
Temperature-Pressure relief valve extension is not fully visible. Unable to evaluate proper extension.

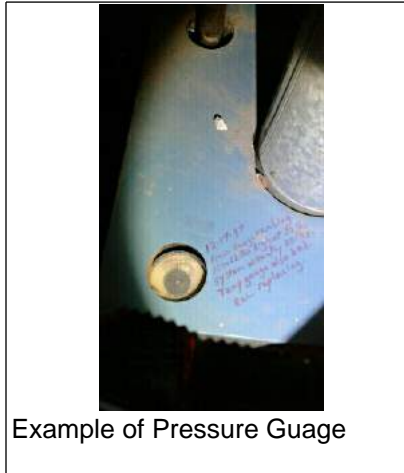
**Comments** Boiler was fair and aging, unit was nearing end of its useful life.  
Boiler pressure Guage not operating, recommend HVAC technician examine prior to use.  
Rust and scorched marks present at boiler inside cover, recommend HVAC technician examine prior to use.

Example of Pressure Guage

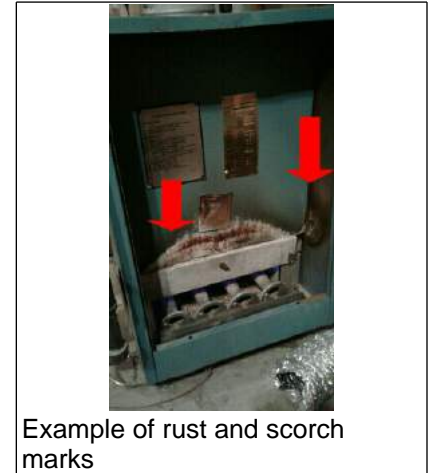
Example of rust and scorch marks

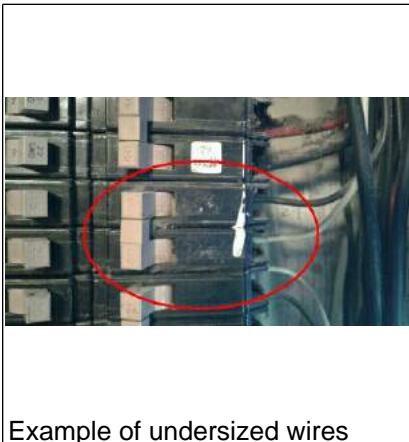
**Comments** Panel was full and may need to be upgraded for future needs.  
Neutral/ground wires were doubled up  
Panel cover was not installed and needs to be reinstalled. Safety Hazard  
Branch wires are under sized - Recommend licensed electrician repair and/or replace as necessary.
