## Home Inspection Report

Main Ave, Spokane , WA 99203

Tuesday December 20, 2016

Home Pride Inspections LLC  
2525 E 29th Ave  
Ste 10B #312  
Spokane, WA 99203  
(509)855-9104  
info@homeprideinspect.com

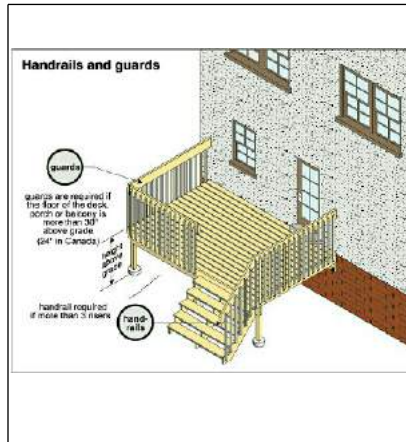
**Comments** Underside of porch not fully visible, no representation is made.  
Porch railing lower than typical safety standards for small humans, recommend repair  
Recommend painting or treating the wood on deck/porch

Example of porch railings

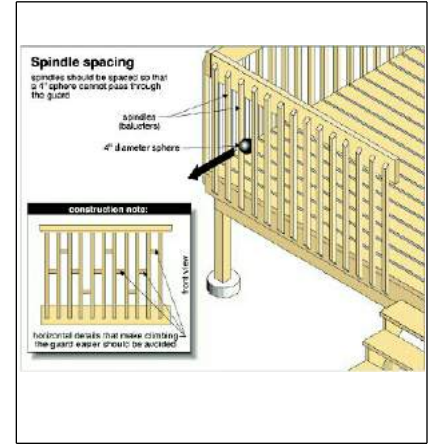
**Comments** Damaged wood on front and back steps, recommend repair and/replacement  
Earth to wood contact at some areas of steps, wood rot present, recommend repair.  
Baluster spacing larger than typical safety standards for small humans, recommend repair.

Example of balusters

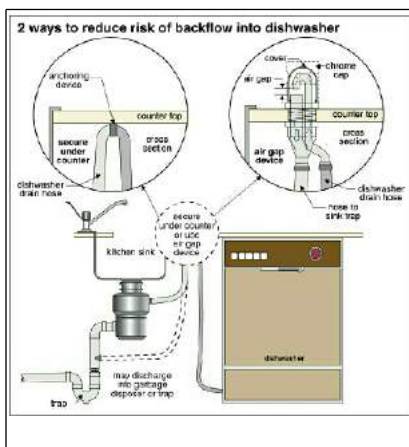
Example of dishwasher drain loop

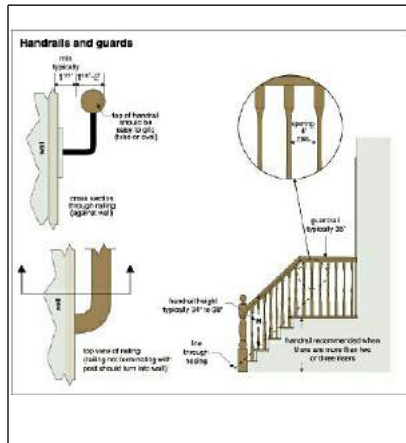
Example of basement stairs

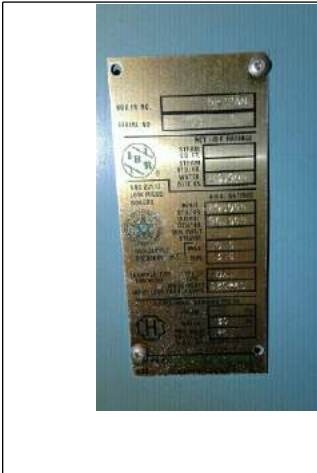
**Comments** Boiler was fair and aging, unit was nearing end of its useful life.  
Boiler pressure Guage not operating, recommend HVAC technician examine prior to use.  
Rust and scorched marks present at boiler inside cover, recommend HVAC technician examine prior to use.
